Deformation Mechanisms of NiAl Cyclicly Deformed
Near the Brittle-to-Ductile Transformation Temperature

NASA Grant #NCC3-116

Final Report December 17, 1992

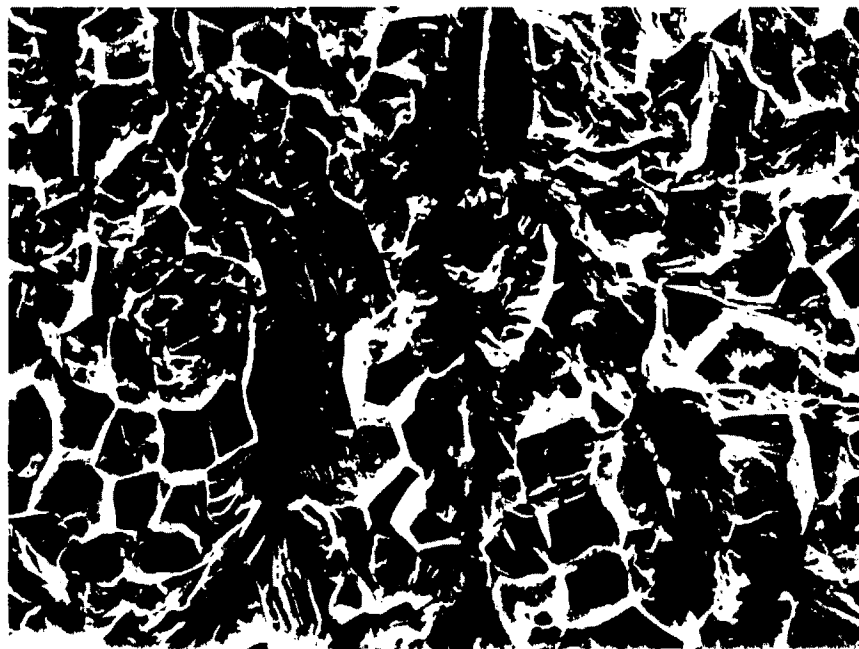
Figure 4.2 - Portion of the tensile fracture surfaces at 700 K showing 28% intergranular fracture. Fracture initiation sites were uncertain for the tensile tests but occurred within the gage section.

The true stress versus true strain data for tensile tests conducted at $\dot{\epsilon} = 10^{-4} \text{ s}^{-1}$ are shown in Figure 4.1 (initial strain off-set from zero for clarity). The room temperature (300 K) test failed elastically. Previous work in NiAl has shown that the fracture stress with zero ductility corresponds to the yield stress. For this heat of material tested at 10^{-4} s^{-1} , the yield stress dropped from 155 MPa at 300 K to 141 MPa at 700 K and the fracture stress increased from 155 to 374 MPa in the same temperature range. The percentage of intergranular fracture, relative to transgranular cleavage, in the fracture surfaces decreased with increasing temperature from $39 \pm 4\%$ intergranular at 600 K to $28 \pm 2\%$ at 700 K, Figure 4.2.

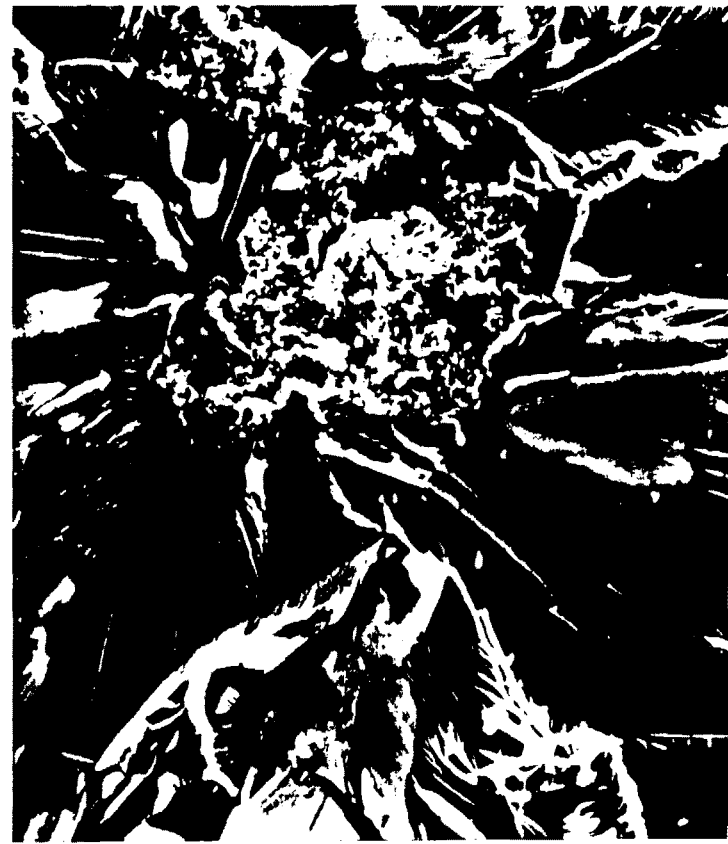
Figure 4.10 - Fracture surface of sample tested at 700 K, $\Delta\epsilon_p = 0.01$ (a) low magnification with inclusion at upper left (b) inclusion. EDX analysis showed high amounts of Al, measurable amounts of Si and virtually no Ni present in the inclusion.

The fracture surfaces of the fatigue tests looked surprisingly similar to those of the tensile tests, Figure 4.10 (a,b). Figure 4.10 (b) shows the internal inclusion that initiated the fracture. X-ray dispersive analysis indicated high levels of Si in the inclusions. These inclusions were non-metallic and quite likely silica which is a common crucible material used in powder production. At 600 K all fatigue fractures initiated at internal inclusions, like the one shown in Figure 4.10 (b). Above the BDTT, some failures initiated at inclusions but repeat test had longer lives and failures were initiated at the surface. Therefore at 675 and 700 K, flaw sensitivity appeared to be diminishing. There were no clear demarcations between areas of cyclic crack growth and fast fracture for any of the specimens. Studying the fracture surfaces would suggest that the critical flaw size was quite small and that fast fracture dominated much of the surface. The regions directly adjacent to the fracture initiation sites were one hundred percent transgranular cleavage, but that is also the case for tensile fracture which initiate at a macroscopic flaw. The percentage of intergranular fracture in the bulk fracture surfaces of fatigue specimens tested at $\Delta\epsilon = 0.005$, Figure 4.11, decreased with increasing test temperature from $47 \pm 6\%$ at 600 K to $33 \pm 4\%$ intergranular fracture at 700 K following the same trends seen in the monotonic failures. Note that the percentage of intergranular fracture for the fatigue test at 675 K and $\Delta\epsilon = 0.005$ was unexpectedly low, 32%, but this specimen failed at a very short life from an unusually large inclusion.

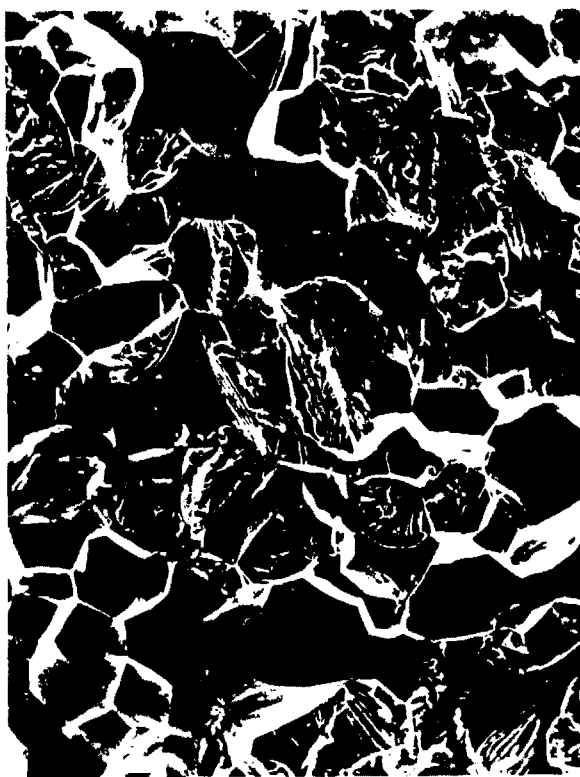
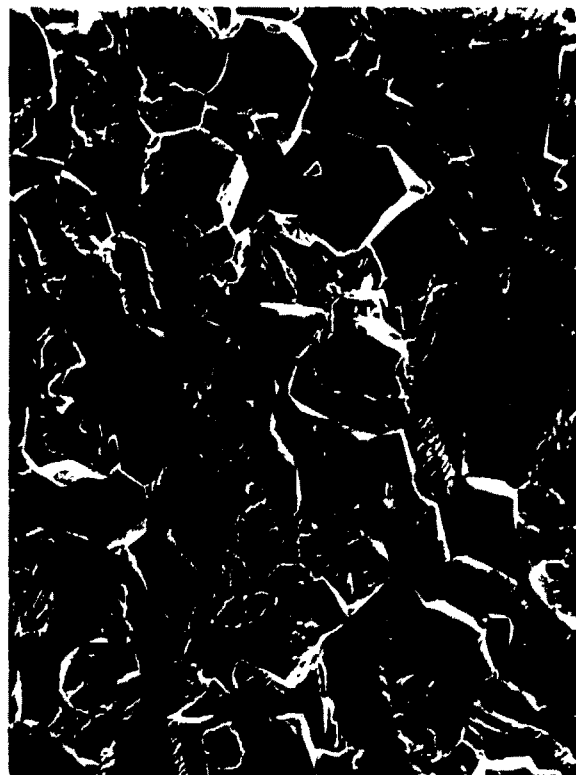
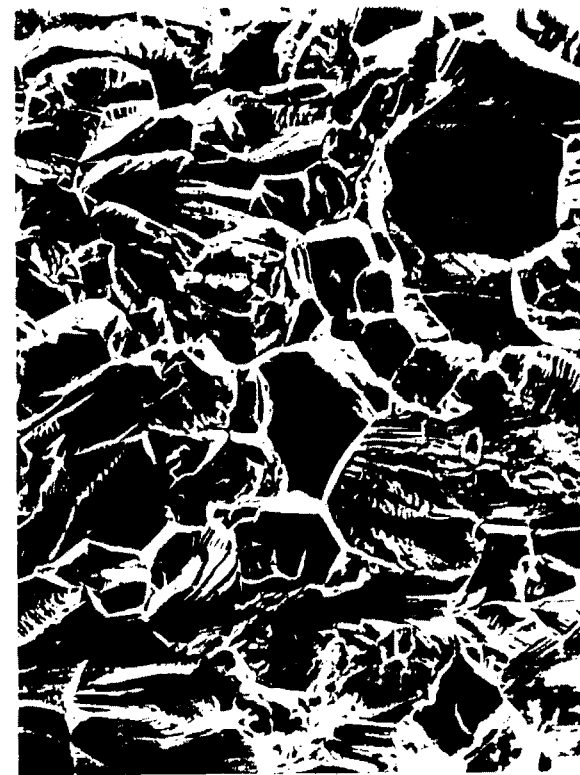
Figure 4.11 - Portion of the fracture surfaces at (a) 600 K (b) 675 K and (c) 700 K showing, respectively, 47%, 32%, and 33% intergranular fracture.

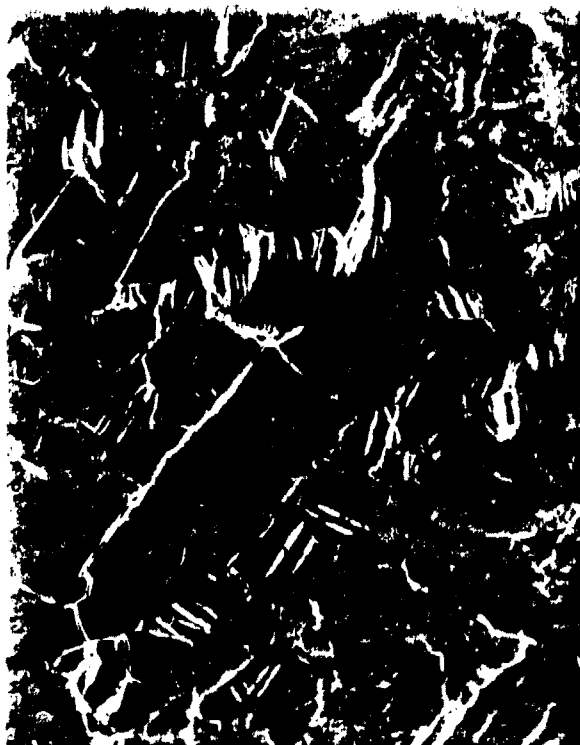
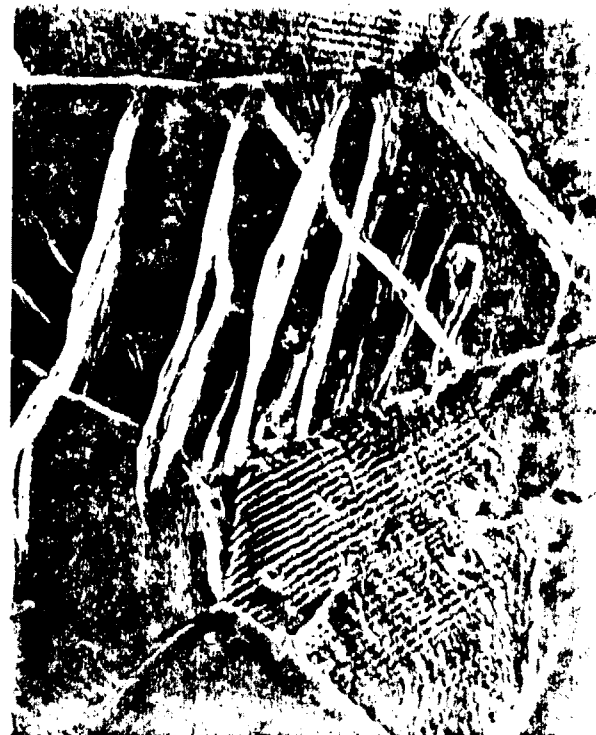
Figure 4.12 - Gage surface of sample tested to failure (region IV) at 700 K, $\Delta\epsilon_p = 0.005$ showing (a) extensive slip traces and (b) distinct extrusions and fine slip lines.

The gage surfaces of fatigue samples showed evidence of deformation. Slip traces and secondary cracking were common on specimens cycled to failure. Surface slip traces occurred at all temperatures and both strain ranges on specimens which reached initial saturation. Figure 4.12 (a,b) shows an example of slip bands which developed into distinct extrusion on the surface of a specimen which failed in region IV. The samples which had lives longer than 1500 cycles showed not only the macroscopic slip bands seen in many samples, but also contained very fine lines, Figure 4.12 (b). These fine slip bands were quite

linear and uniformly spaced, and were only observed in specimens which were deformed into region IV. The concentration of slip traces was slightly higher near the fracture surface, but they were not limited to the center of the gage section. Even surfaces which had fairly sparse bands of intrusions/extrusions had bands extending to the shoulder radius, Figure 4.13 (a,b). Transgranular cracks were seen forming at some deep slip bands. In addition, intergranular cracks were seen opening between grains which contained slip traces.

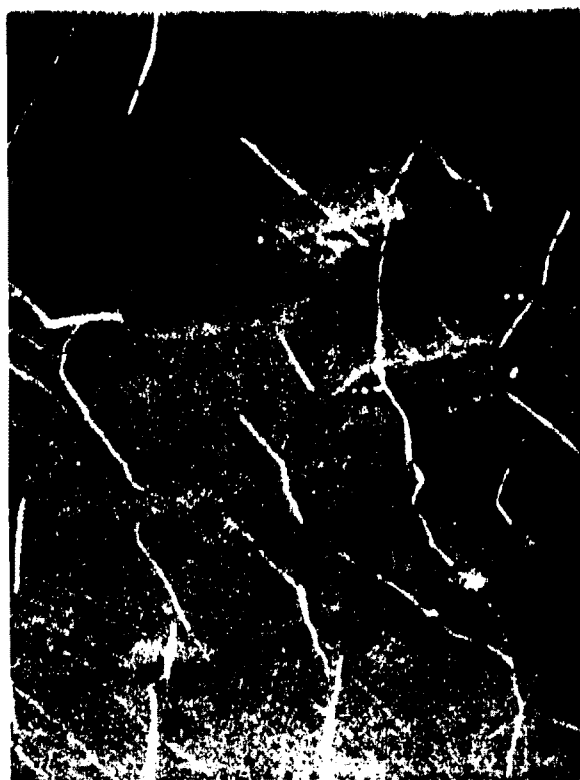
Figure 4.13 - Gage surface of sample tested to failure at 600 K, $\Delta e_p = 0.01$ showing regions of slip traces (a) near the fracture surface and (b) near the radius

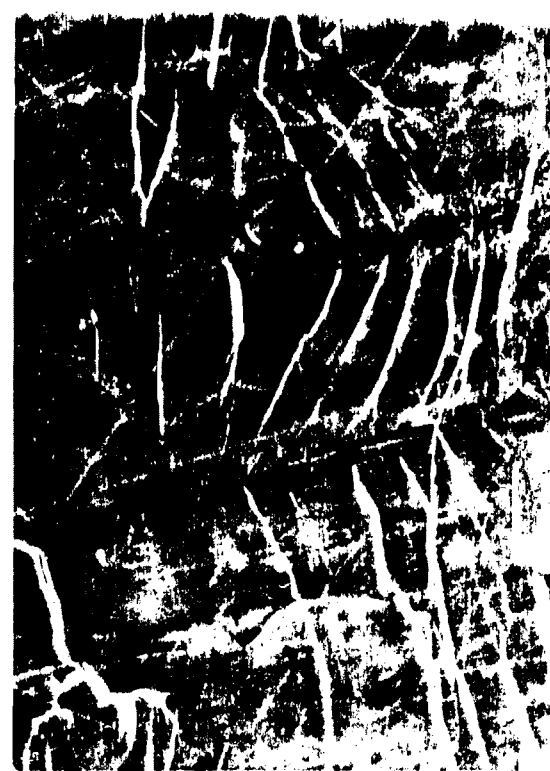
Figure 4.14 - Specimens deformed at 600 K and $\Delta\epsilon_p = 0.005$ (a) interrupted in region I, i.e. while cyclicly hardening, (b) interrupted in the beginning of region II, i.e. at the onset of stability, (c) failed in region III.

Surface deformation was found to increase with the amount of imposed deformation and with decreasing test temperature. Figure 4.14 tracks the increasing deformation density for samples tested at 600 K and $\Delta\epsilon_p = 0.5\%$. The two specimens tested at 600 K and $\Delta\epsilon_p = 1.0\%$, Figure 4.15 (a,b), failed at the beginning of region II and revealed the most striking evidence of increasing deformation density. Both failures were initiated at internal inclusions; one of the specimens failed after 8 cycles and the other after 10. The surface deformation on the sample with 10 cycles 4.15(b) was noticeably more extensive than the deformation on the sample with 8 cycles 4.15(a). Three examples are included of the effect of increasing temperature on the extent of surface deformation. Figures 4.16 and 4.17 show surfaces from samples deformed at 700 K to the onset of stability (beginning of region II) at $\Delta\epsilon_p = 0.5\%$ and 1.0% , respectively. The sample tested at 600 K Figure 4.14 (b) had sparse but noticeable bands of intrusions and extrusions while the surface shown in 4.16 tested at 700 K more closely resembles a tensile test or undeformed sample. The sample shown in Figure 4.17 can be compared to 4.15(a,b) above. Although there was evidence of embryonic slip bands forming at the beginning of stability at 700 K Figure 4.17, they were noticeably less developed than either of the samples shown in 4.15 which were tested at 600 K. Figure 4.18(a,b) were both tested above the BDTT and interrupted in stage III. Although the sample tested at 675 K had 100 cycles less than that tested at 700 K, the surface deformation was more developed as a result of the lower test temperature.

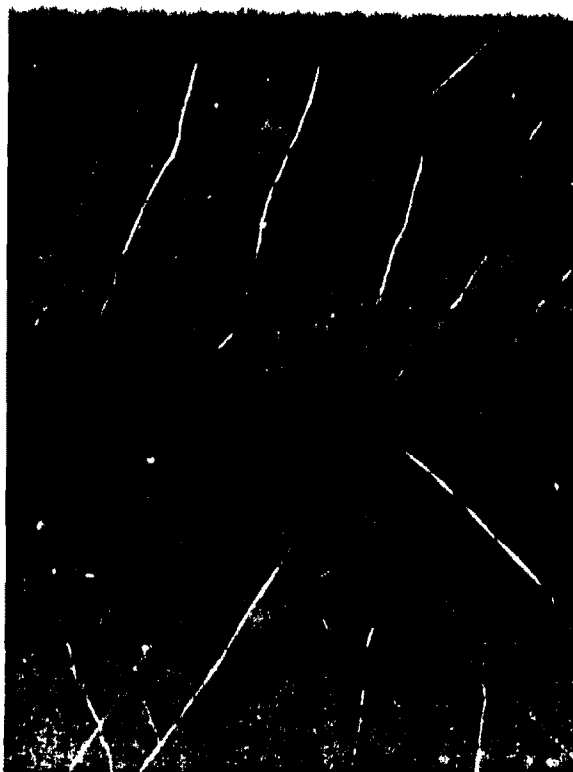
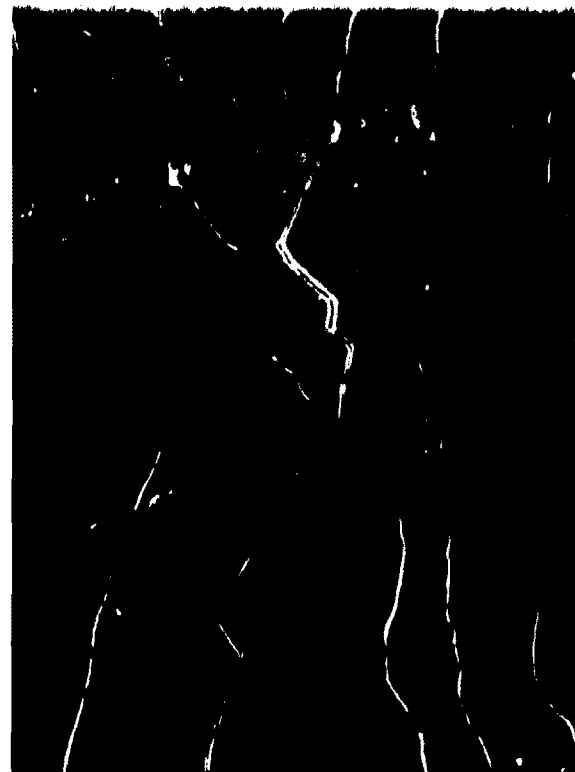
Figure 4.15 - Specimens deformed at 600 K and $\Delta\epsilon_p = 0.01$ both failed at the beginning of region II as the result of internal inclusions (a) $N_i = 8$ and (b) $N_i = 10$.

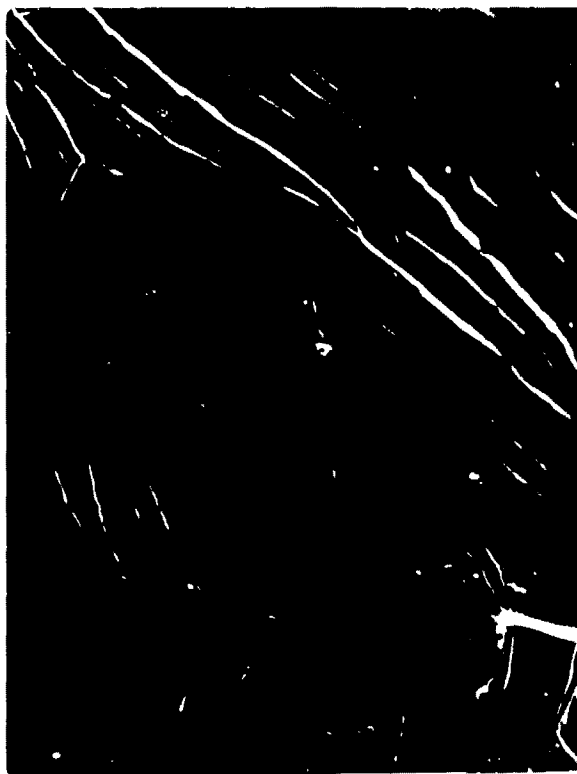
Figure 4.18 - Specimens deformed $\Delta e_p = 0.01$ (a) 675 K and (b) 700 K. Both failed in region III as the result of inclusions. The intrusions/extrusions were more developed in (a) as the result of the lower test temperature even though specimen (a) failed 100 cycles before specimen (b).
